RE: Report of Nuclear Roof Moisture Survey
Orlando Public Library
Roof Section 1
101 E. Central Boulevard
Orlando, FL 32801

The roof system at Roof Section 1 is comprised of low slope built-up roof system with a modified bitumen membrane. The roof system components are as follows (as viewed from the deck up): lightweight insulating concrete (with EPS foam), two modified bitumen inner plies, polyisocyanurate insulation, Securock cover board, two modified bitumen inner plies with a granule surfaced capsheet membrane. Roof Section 1 totals approximately 6,100 SF.

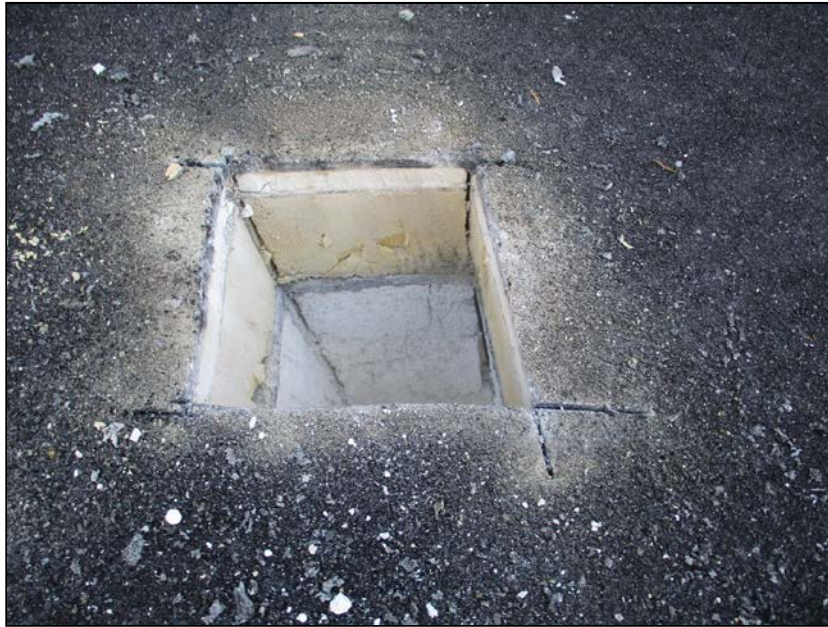
Photo 1: Core location C6, nuke reading 6 – relatively dry.

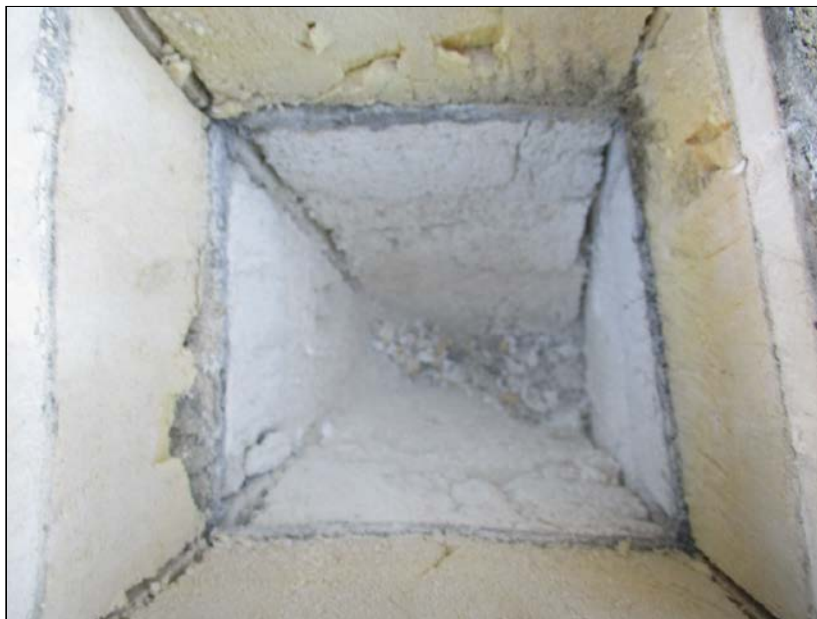
Photo 2: Core location C6, nuke reading 6 – relatively dry.

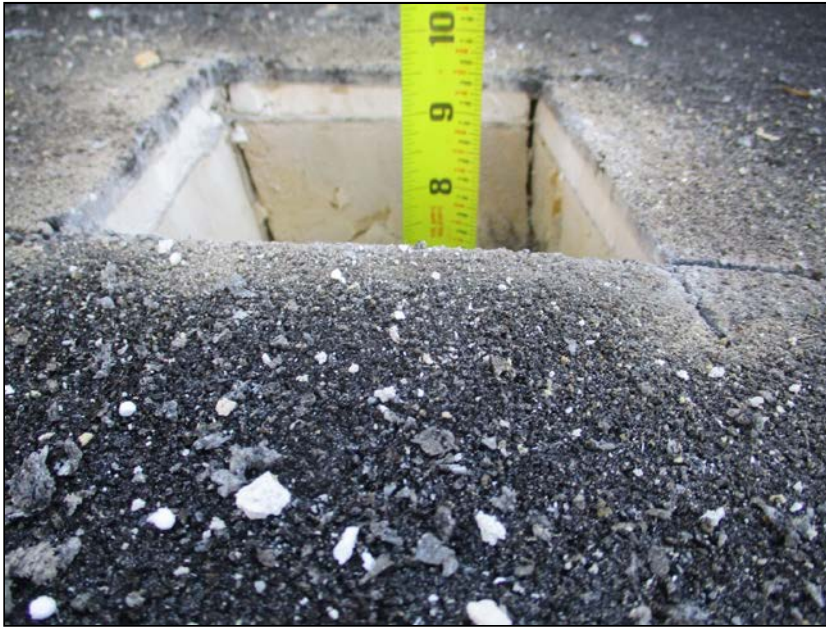
Photo 3: Core location C6, nuke reading 6 – core thickness.

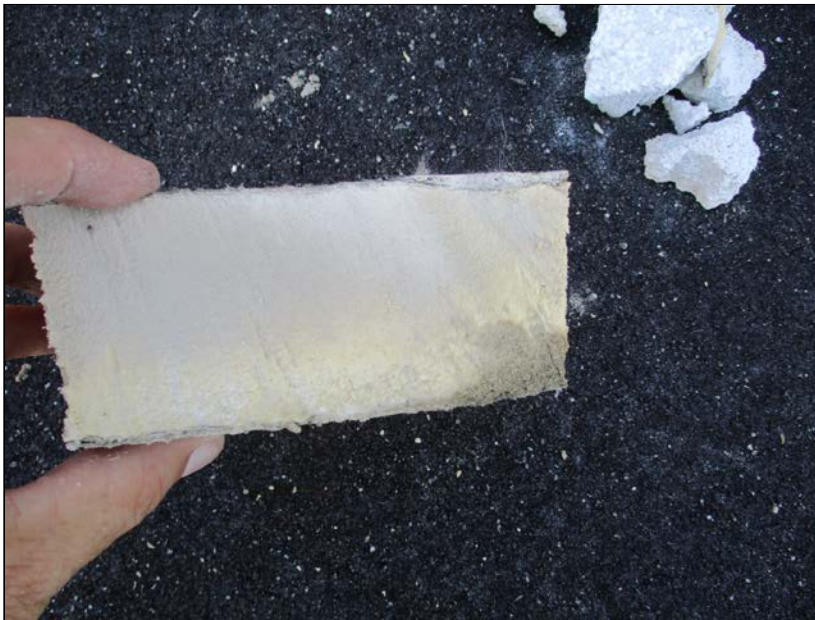
Photo 4: Core location C6, nuke reading 6 – polyiso insulation.

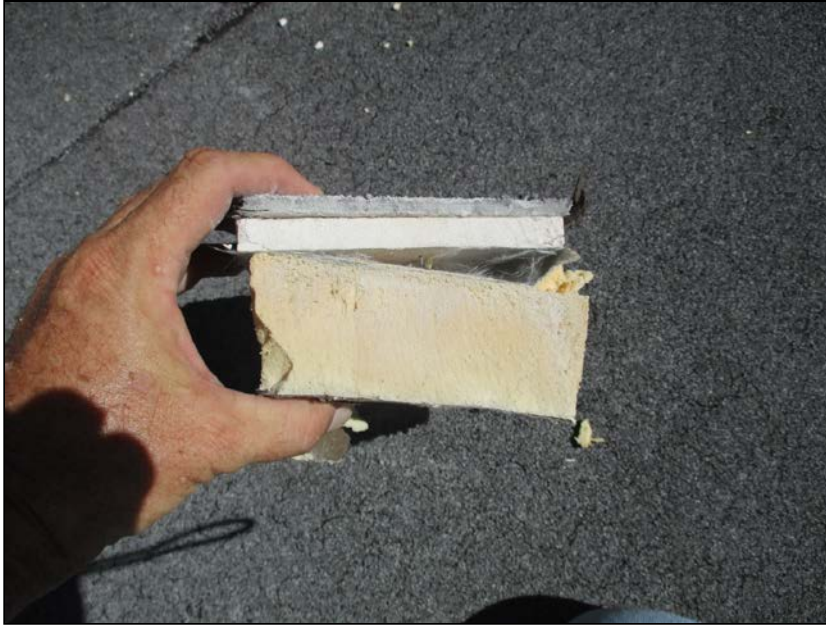
Photo 5: Core location AC5, nuke reading 8 – relatively dry roof components.

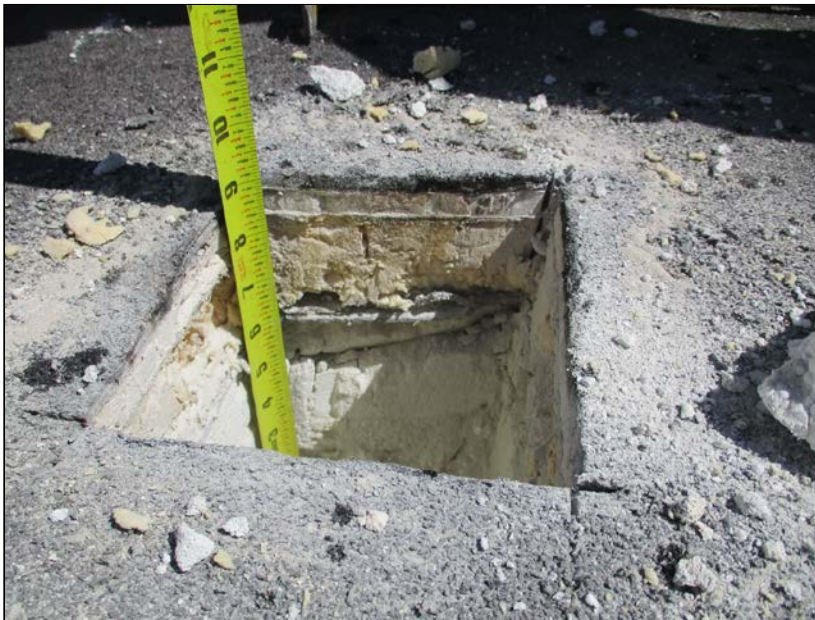
Photo 6: Core location AC5, nuke reading 8 – core thickness.

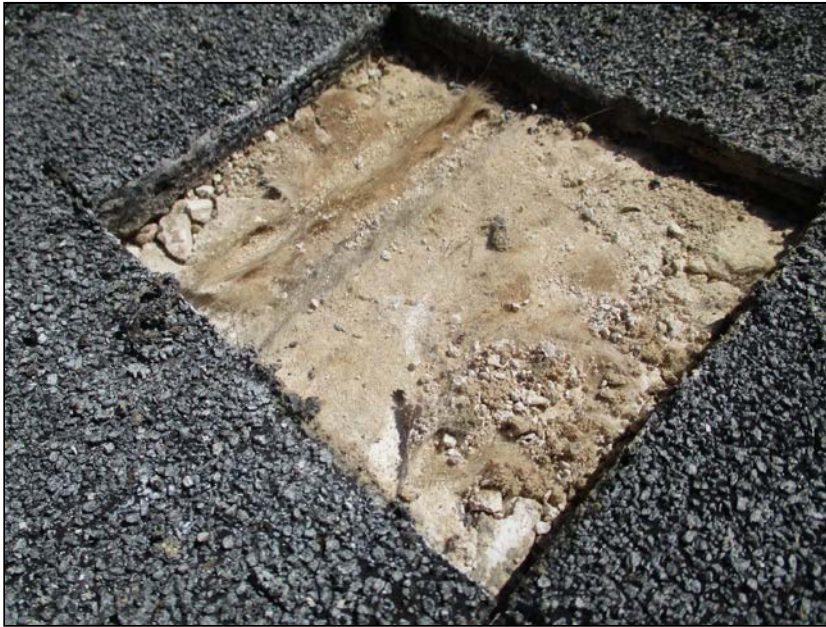
Core Location / Nuke Reading	Core Thickness	Observation
C6 / 6	9.5"	Roofing components dry
AC5 / 8	9"	Roofing components dry
R3 / 20	9"	Insulation and Securock boards moist

Photo 7: Core location R3, nuke reading 20 – cover board discoloration.

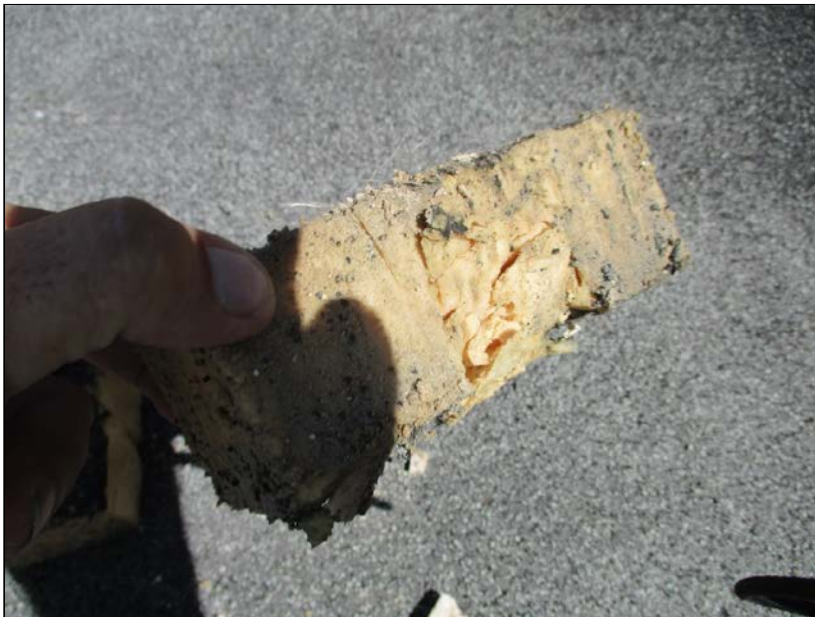
Photo 8: Core location R3, nuke reading 20 – polyiso insulation board.

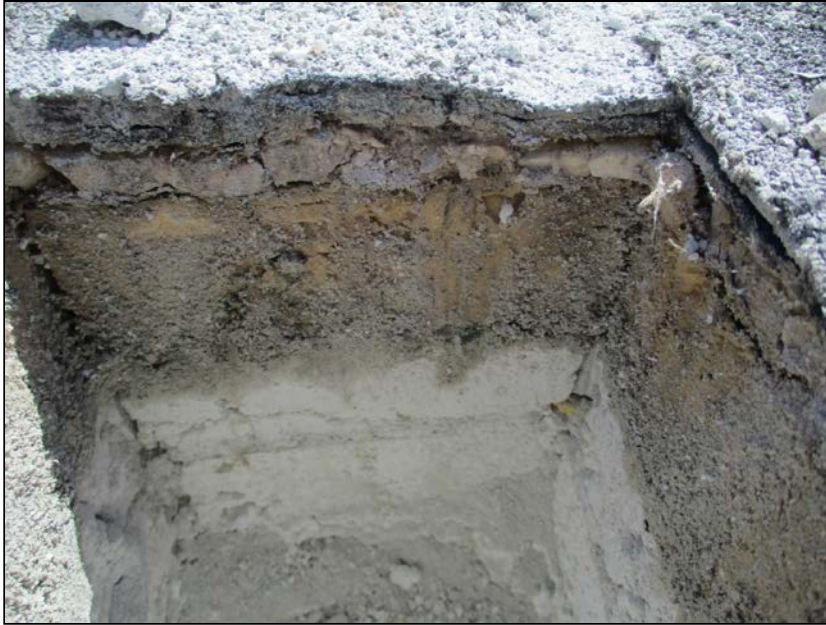
Photo 9: Core location R3, nuke reading 20 – moist conditions at Securock cover board and polyiso insulation boards.

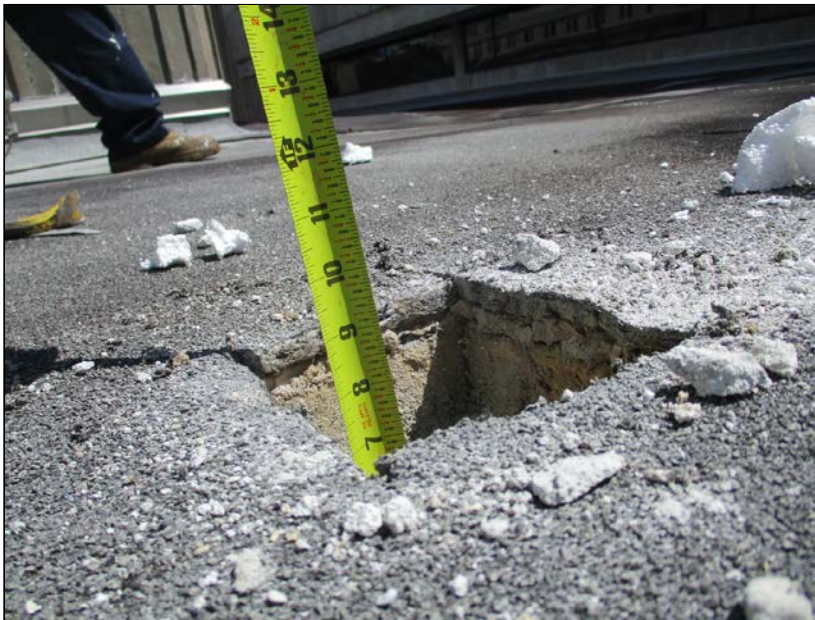
Photo 10: Core location R3, nuke reading 20 – core thickness.

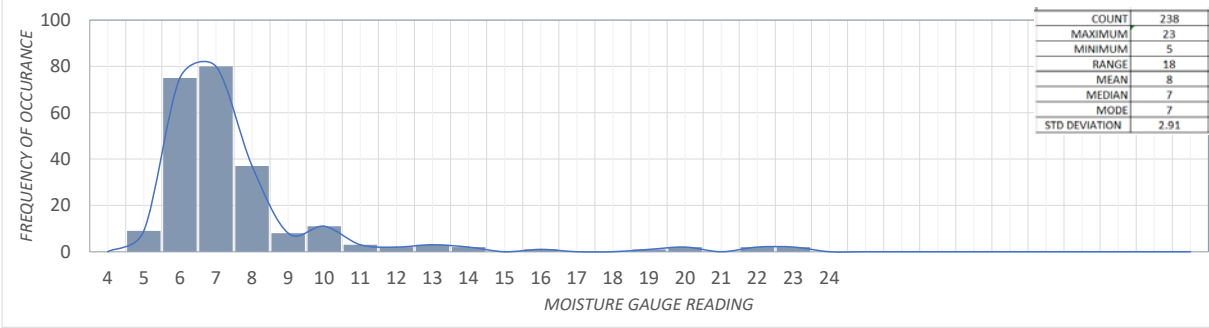
FIGURE 1
MOISTURE READINGS HISTOGRAM
Roof Section 1

Based on the data obtained in the field, a normal distribution curve of the sampled readings was formed. Please refer to the attached documents for results. The mean and standard deviation of the sample set were calculated. As stated in TAS 126-95, Section 13.5.2: Statistically, 99.7% of the measurement counts for the dry areas of the roof will fall between one to three standard deviation limits with the different varying levels of moisture. This is further calibrated via the gravimetric analysis and roof core sample analysis performed.

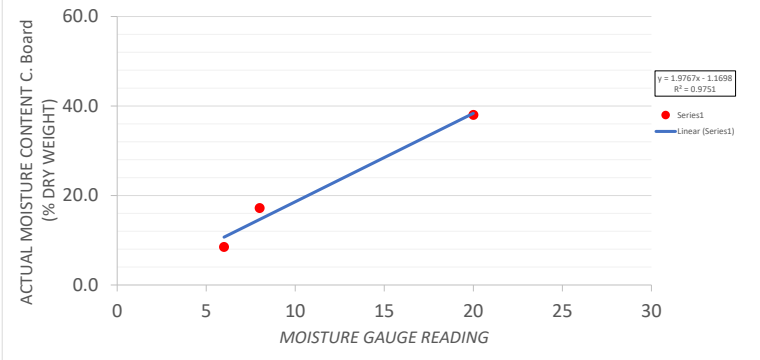
FIGURE 2
ACTUAL MOISTURE CONTENT VS. MOISTURE GAUGE READING
LINEAR REGRESSION CURVE
Roof Section 1

At the conclusion of the moisture survey and laboratory analysis of core samples obtained, the moisture content value for the roofs membrane and perlite cover board of each core sample was plotted on a linear graph versus the corresponding moisture scan reading. A best-fit linear regression curve and corresponding best-fit line slope equation were developed. The line slope equation describes average moisture percentage by dry weight as a function of the moisture scan readings. This function was compared to the histogram of gauge readings and statistical analysis as well as the visual survey of the cores in the field

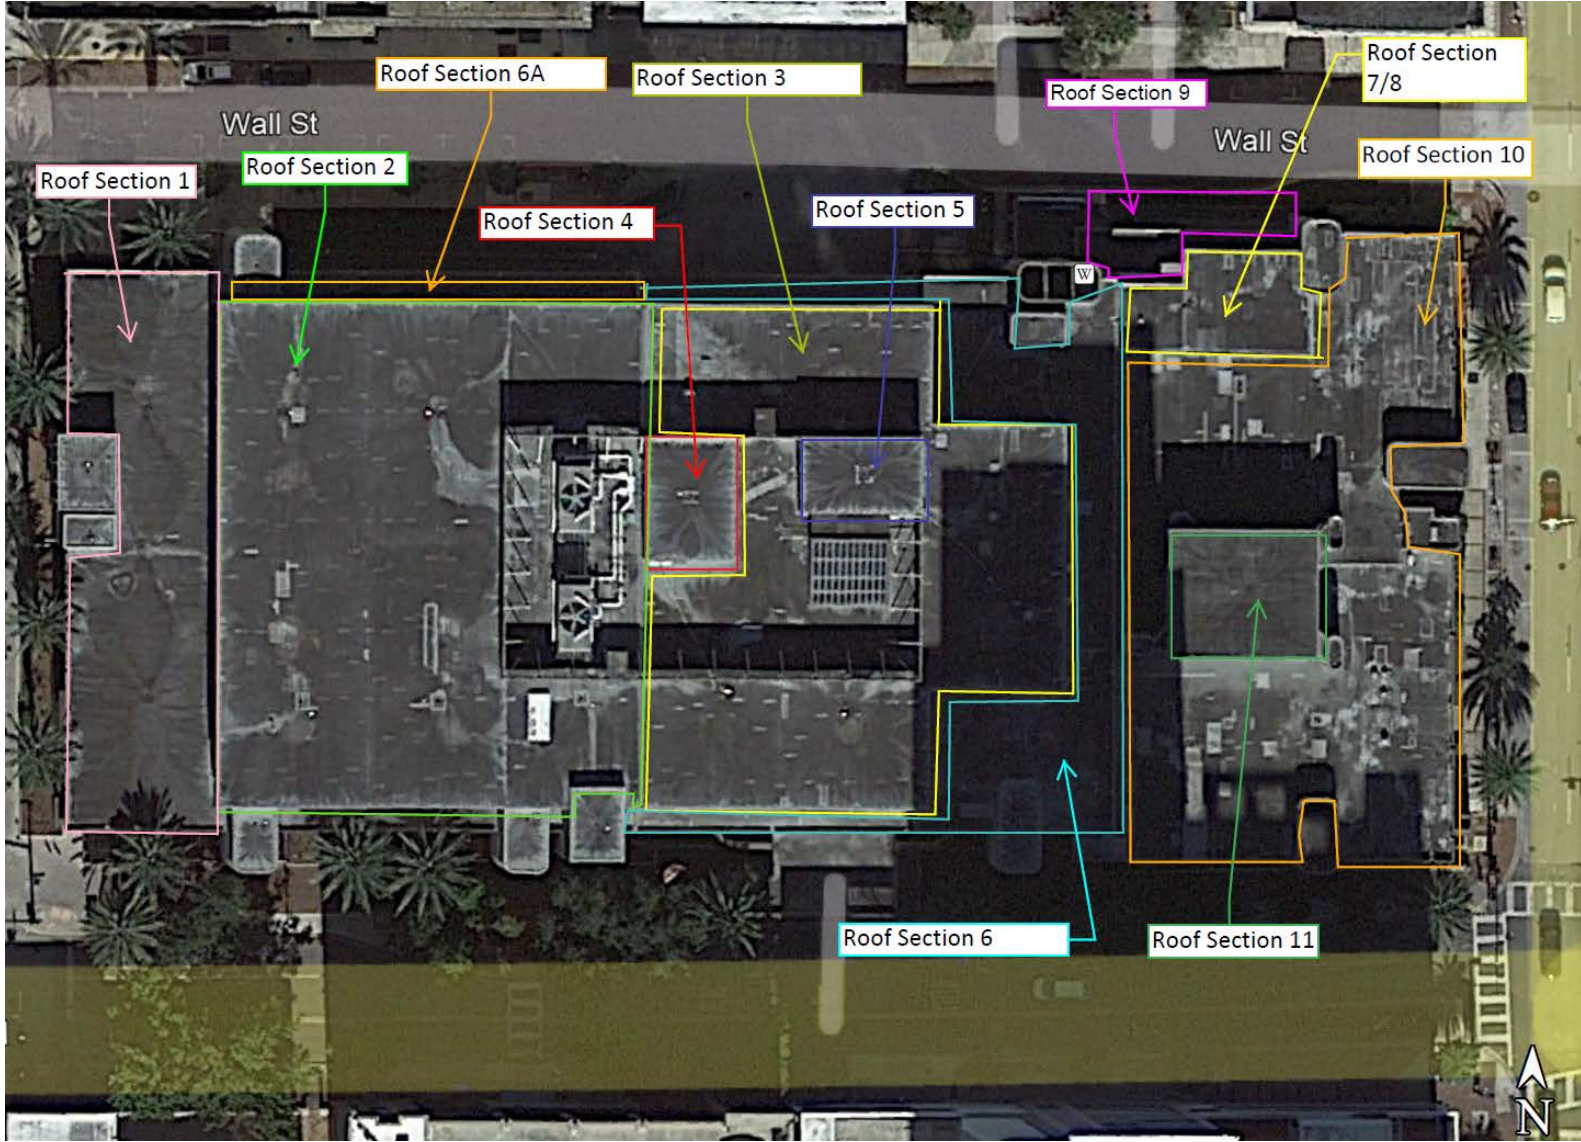
Overall Annotated Roof Aerial Map
Orlando Public Library
Orlando, FL

Roof Section	Approximate Roof Area	Suspect Moisture Roof Area	Wet Area	Total Area of Concern
1	6,100 SF	75 SF	175 SF	250 SF (4.1%)
